Rupture of Extra-Corporeal Circuit Tubing During Cardiopulmonary Bypass

Abstract: Roller pumps are widely used for cardiopulmonary bypass in developing nations by virtue of proven safety during several years of institutional use and cost effectiveness. However, careful adjustment of roller occlusion is needed because they are known to cause spallation, tubing wear, and the occasional incident of rupture of tubing in the extracorporeal circuit. Rupture of polyvinylchloride tubing in the pump raceway during repair of a ventricular septal defect in a 4-year-old child is discussed. The event was managed by exclusion and replacement of the defective tubing during a short period of arrest. Use of an inappropriate boot pump and failure to detect its inclusion in the

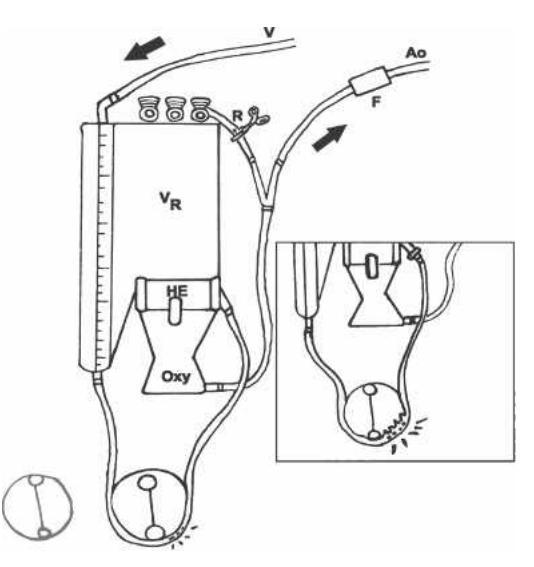
During the phase of rewarming, slow leakage of blood from the arterial pump raceway was noted at a core temperature of 34°C (Figure 1). The degree of leakage was increasing in proportion to the flow rate. There was no antecedent increase in the arterial line pressure, and a 30-mmHg fall occurred after the event. On closer inspection, blood was seen to leak from the PVC tubing beyond the point of maximum occlusion (Figure 1, inset). No macroscopic air was sucked into the circuit. An emergency plan to induce temporary circulatory arrest, exclude the ruptured tubing, and re-establish circulation through an adjacent module was formulated.

Figure 1. Schematic depiction of the dehiscent tubing within the arterial roller pump housing. Inset, Site of rupture.

A partial dehiscence of the tubing on the positive side of the roller pump raceway at the point of maximum occlusion was noted.

This incident occurred during the phase of rewarming as full flows were being restored. Although higher revolutions per minute were required to maintain target flows (Table 1), it is speculative to attribute the event entirely to an exaggerated shear stress on the1/4-in. pump boot. Because the occlusion settings and duration of the perfusion were within acceptable limits, a manufacturing flaw could also have contributed to failure of the tubing.

Dehiscence of the tubing on the positive side of the raceway prevented air from being sucked into the circuit.

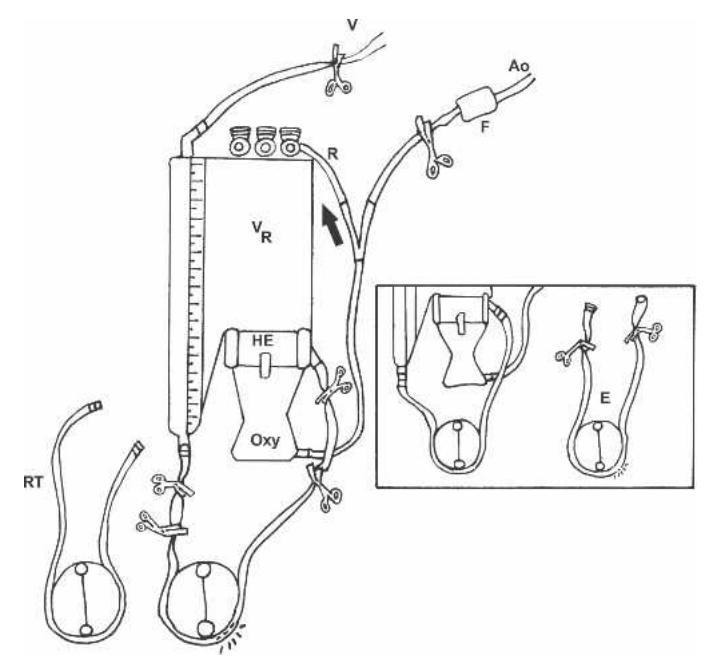
Low flows were maintained by reducing the core temperature to 26°C. Intravenous thiopentone sodium and methyl prednisolone were administered and ice packs were placed around the head of the child to ensure cerebral protection. Replacement tubing with appropriate connectors was passed through an adjacent module, which was re-calibrated, and the occlusion settings were readjusted. At this juncture, flows were further reduced, and temporary circulatory arrest was induced (Figure 2). The ruptured tubing was divided between clamps at the venous

outlet and oxygenator inlet ports and excluded from the circuit. Replacement tubing was connected to the respective ports (Figure 2, inset), the new circuit was de-aired through the recirculation line, and clamps on the patient side were removed to re-establish circulation. The surgical procedure was continued during this brief period, and the child was weaned off CPB in a stable hemodynamic condition. The CPB and aortic clamp times were 76 and 39 minutes, respectively. Circulatory arrest time was 1.5 minutes. Low flows were maintained through the ruptured

Figure 2. Schematic depiction of the arrested extra-corporeal circulation and passage of replacement tubing (RT) through an adjacent pump head. Inset, Replacement tubing in place with exclusion of the damaged tubing and the roller pump (E). Arrows, direction of blood flow; V, venous line; $V_{\rm R}$, venous reservoir; HE, heat exchanger; Oxy, membrane oxygenator; F, arterial line filter; R, recirculation line; Ao, arterial line.

An arterial line filter prevented the propagation of microemboli and the recirculation line was invaluable for deairing the new circuit. Hypothermia enabled reduction of flow rates and control of volume loss from the ruptured tubing in addition to ensuring cerebral and myocardial protection.
